**Development of Hong Kong?**

**長遠防治山泥傾瀉計劃相關的綠化工程**  
**Greening Works Associated with Landslip Prevention and Mitigation Programme**

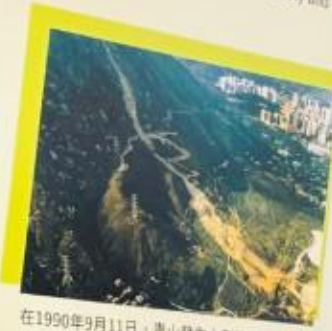
在1990年9月11日，青山發生大型泥石流。如果坡腳當時已發展為住宅區，泥石流將會沖擊大廈，造成嚴重災害。

On 11 September 1990, a serious debris flow occurred in Tsing Shan. If the slope toe had a residential area, the debris flow would have had catastrophic consequences.

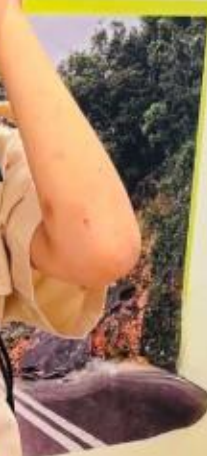
在2025年8月5日，大潭道旁的一幅削土坡在暴雨前警告信號生效下發生了山泥傾瀉。

On 5 August 2025, a landslide occurred on a cut slope adjacent to Tai Tam Road under the black rainstorm warning.
